CIVIL AERONAUTICS BOARD

ACCIDENT INVESTIGATION REPORT

CONTINENTAL CHARTERS, INC., NEAR LITTLE VALLEY, NEW YORK
DECEMBER 29, 1951

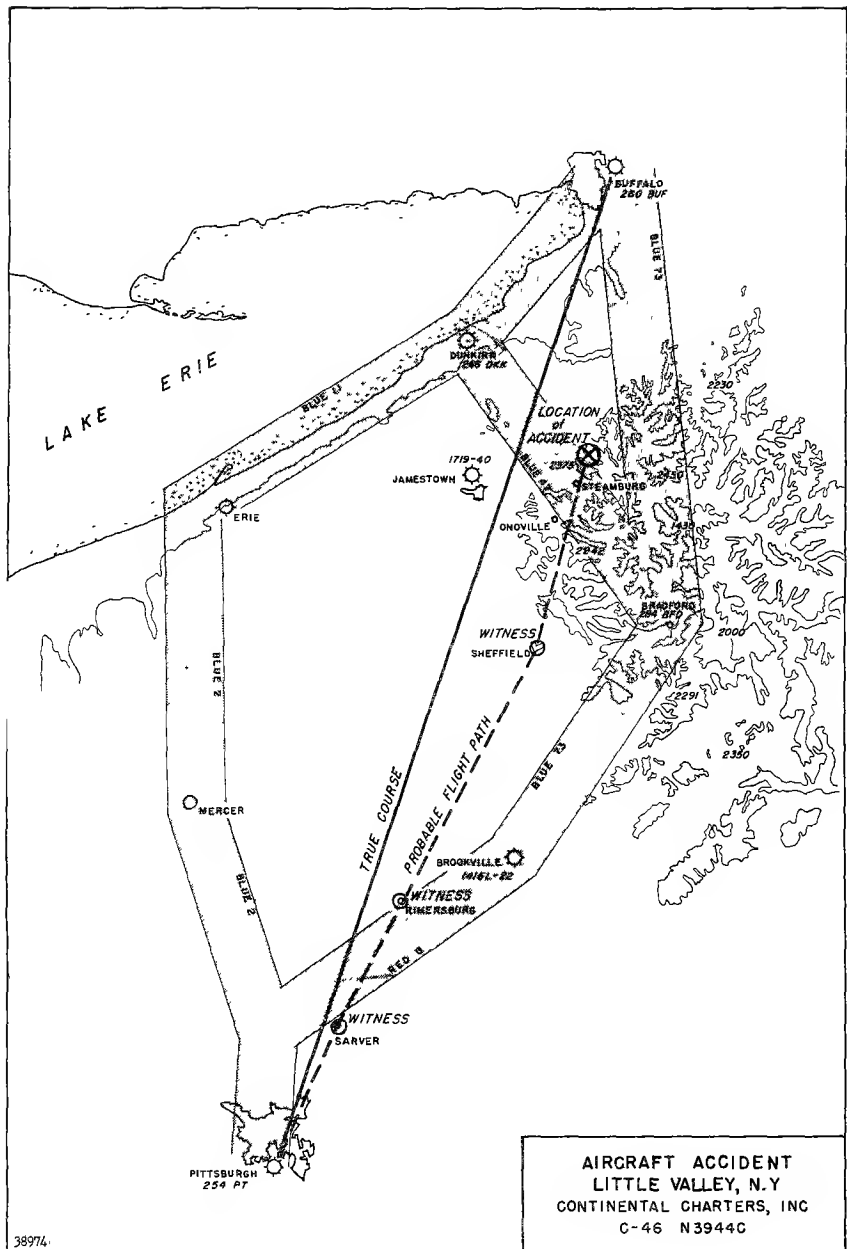
AIRCRAFT ACCIDENT
LITTLE VALLEY, N.Y.
CONTINENTAL CHARTERS, INC
C-46 N3944C

Investigation at the scene indicated that the accident occurred about 100 feet below the crest of a hill, at an altitude of 2375 feet MSL, while the aircraft was in level flight and on a true heading of approximately 18°. Indications were that first contact was with small branches of a tree 60 feet above the ground. From this point on, as forward travel continued, disintegration of the aircraft progressed along a path 933 feet beyond the point of initial impact. All major components were accounted for along this path. Disintegration of the aircraft was complete with the exception of the aft part of the passenger compartment which came to rest at the most distant end of the line of travel.² It was in this section that
